NASA/TM—2002-211509

RQL Sector Rig Testing of SiC/SiC Combustor Liners

Michael J. Verrilli and Lisa C. Martin
Glenn Research Center, Cleveland, Ohio

David N. Brewer
U.S. Army Research Laboratory, Glenn Research Center, Cleveland, Ohio

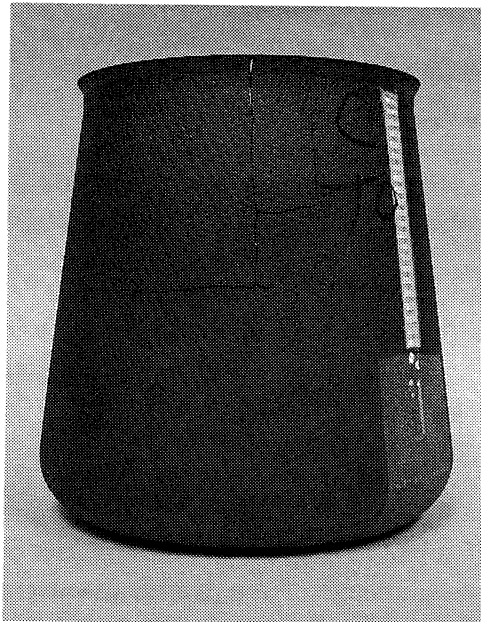
Cracking was found after the first test run of 7.5 hours in the CR side RZL (555-07-009). The crack initiated at the leading edge, grew about 2-3/4 in. along the flow direction, and bifurcated, turning 90° (i.e., in a circumferential direction). Another 90° crack branch existed about 1-3/4 in. from the leading edge (Figure 7). Propagation of these circumferential cracks was observed after the second test run of 8 hours.

Figure 7 – Post test picture of cracking in rich zone liner 555-07-009.
Note the thin film thermocouple and wire leads.

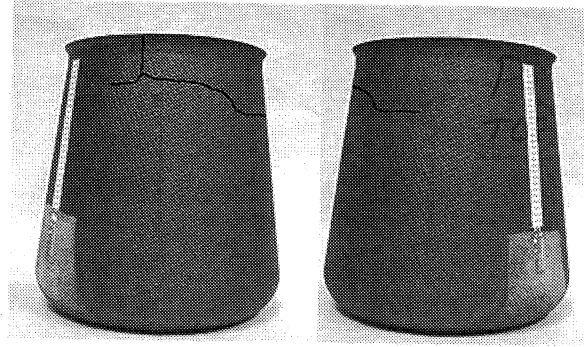
After the second test run, cracking that initiated at the leading edge was detected in the PL side RZL (555-07-010) as well. The crack was about 3/4 in. long, in a direction parallel to the flow direction, and it bifurcated. The circumferential portion of this crack spanned over 90° of the RZLs circumference, Figure 8. Relative displacement of the crack faces perpendicular to the flow direction was imaged with the boroscope. To avoid further damage and potential RZL failure during subsequent testing, both RZLs were removed and replaced with new ones. The replacement PL-side RZL (253-07-210) developed a leading edge crack after the third test run. Boroscope inspection after the fourth run imaged a second leading edge crack, 180° apart from the initial crack. The second crack initiated on a fiber cloth splice that was visible on the inner diameter of the RZL (Figure 9). Continued propagation of these two cracks was

Figure 8 – Post test pictures of rich zone liner 555-07-110, a) initiation site of crack at leading edge and branching in a circumferential direction, b) rotated view the can, showing the location of the crack tip.

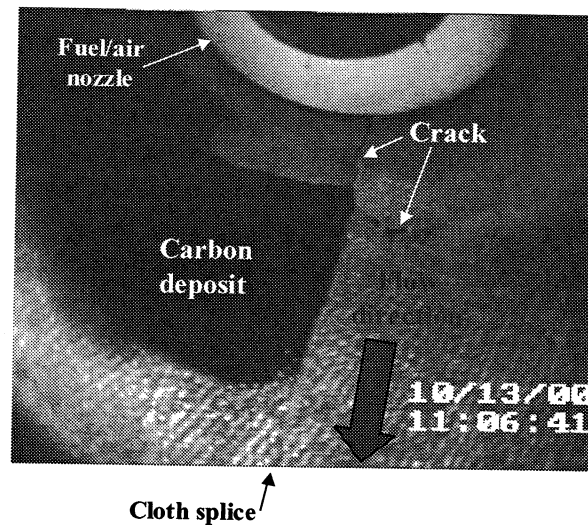
Figure 9 – Boroscope image of the ID of rich zone liner 253-07-210 showing crack initiation and growth from the leading edge on a ply splice.

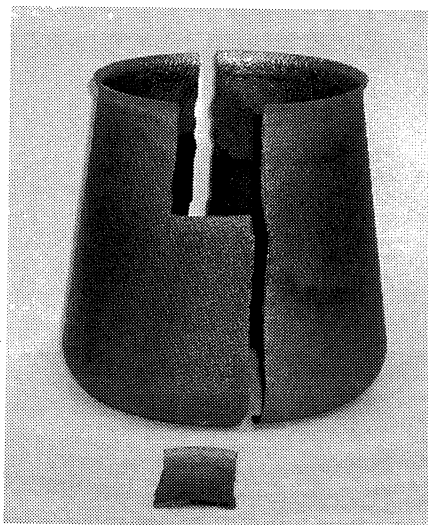
Inspection after the sixth run revealed that failure of the PL-side RZL occurred. An independent 2 in. long by 1-3/4 in. wide section was created when a new leading edge crack linked with an existing crack that had turned in a circumferential direction (Figure 10). Testing was suspended due to this damage. Note that the extensive cracking caused the RZL to split into two halves upon removal from the sector rig.

Figure 10 – Post-test view of PL-side RZL (253-07-210) showing damage that occurred after 40.5 hours of testing.

ranked lower than the six tested in 1999. In particular, the last PL-side RZL (253-07-210) that failed (Figure 10) had the lowest rank of the ten.

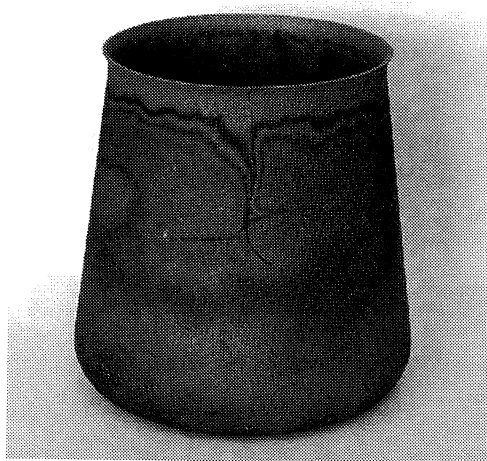
Figure 11 – Post-test image of CR-side RZL (555-07-005). Note the oxidation and crack originating from the leading edge.

A post-test image of the replacement CR-side RZL is shown in Figure 11. Similar to the PL-side RZL, a 2 in. leading edge crack that turned 90° exists.

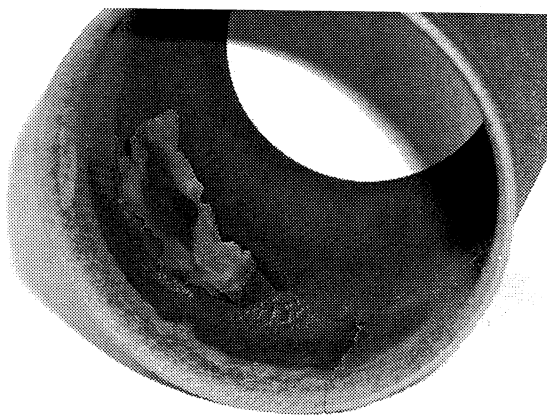
Carbon deposits are present in every tested RZL (Figure 12). Boroscope inspections revealed that carbon deposits form during the initial test exposure and grow with continued testing. Once formed, these carbon deposits typically remained on the ID of a RZL unless they grow significantly in a direction normal to the flow. In these cases, the forces of the flowing gas stream fracture the carbon deposits. Evidence indicating the results of carbon deposit growth and fracture was the large quantities of carbon nuggets that accumulated in the cooling water used downstream of the combustor.

Figure 12 – Carbon deposits and cracking in CR-side RZL (555-07-005) after 40.5 hours of testing.

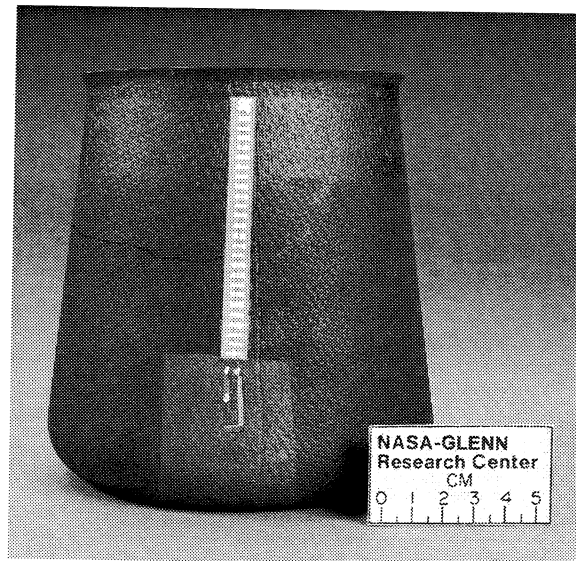
Figure 16 – Condition of a thin film thermocouple on a rich zone liner after combustion exposure.

Post-test analysis of the thermocouples revealed that the thin film thermocouples were intact and electrically continuous. There appeared to be very little physical damage to the films (Figure 16). However, the welds that held the platinum-13% rhodium wires to the films failed. The aluminum oxide insulation films were intact for all but one of the thermocouples. The fourth thermocouple had some flaking in the aluminum oxide film, resulting in lowered

The post-test analysis of the sensors indicated that the thin films and leadwires survived the test conditions, however the welds between the wires and thin films did not. The wires did not maintain full and intimate contact with the films. This may have contributed to the erratic data that occurred during the temperature increase after the combustor was lit. In particular, the platinum-13% rhodium wires failed to remain in contact with the films. This may have been due to oxidation of the rhodium in both the wire and the exposed film. During sensor fabrication, the film was not completely covered by the protective aluminum oxide overcoat to allow attachment of the leadwires. The degradation in the output signals during high temperature exposure may have been caused by a change in the composition of the exposed films and fine wires. Analysis of the thermocouple data indicates that the connections between the wires and films failed prior to the initiation of the actual sector testing, during the initial period during which the hardware was exposed to high temperature, high flow air. The

While the thin films proved to be physically durable during this testing, the failure of the wires and the degradation in the signal output demonstrates that the thin film-to-leadwire connections need to be improved for durability and the thin films need to be more fully protected from the harsh test environment.
